-- GRANITE LAKE DAM --
VISUAL INSPECTION/EVALUATION REPORT

Dam Name: Granite Lake Dam

Date of Inspection: October 8, 2024

Re: Visual Inspection/Evaluation Report
Granite Lake Dam – NH ID D166002
Nelson, New Hampshire 03457

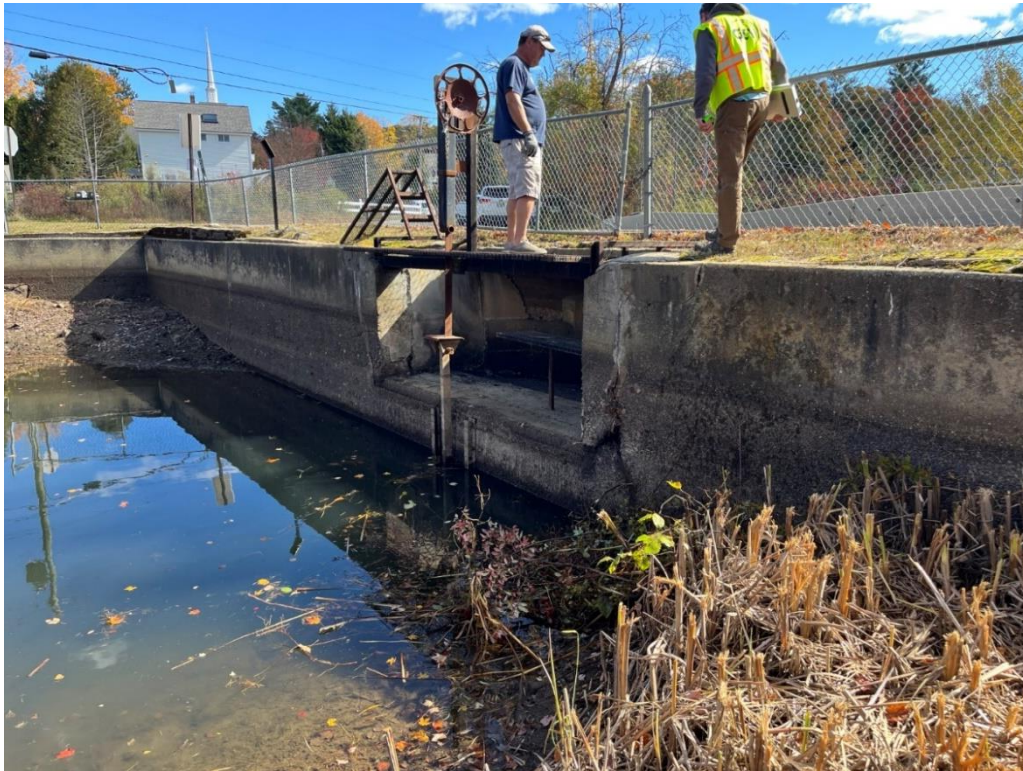
Photo 1: Upstream side of dam. Note spillway intake and low-level gate at center.

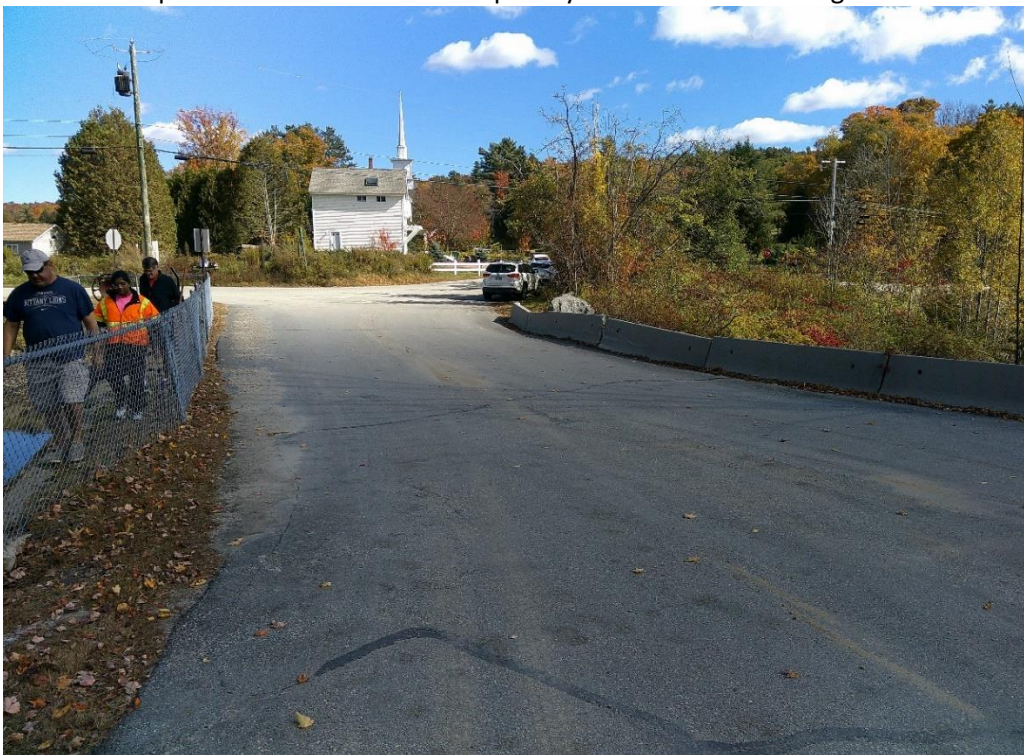
Photo 2: Top of dam from right abutment.

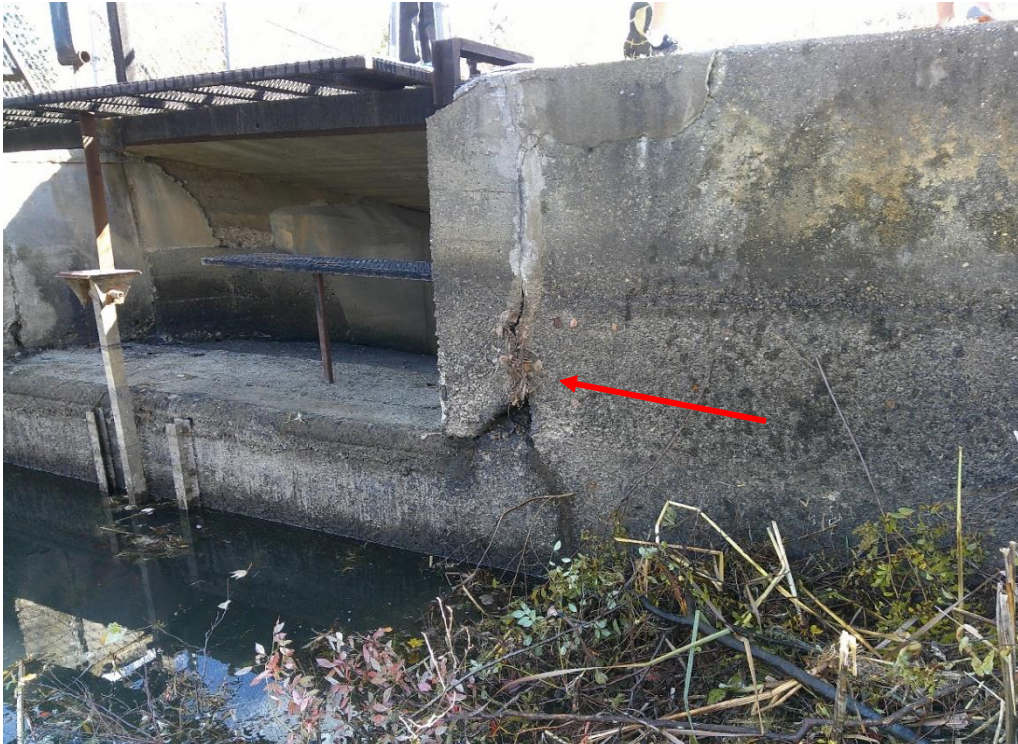
The concrete facing along the upstream side of the dam is in fair to satisfactory condition with localized spalled areas and vertical cracking. Spalling is somewhat greater in areas below the normal pool level. There are small sections of moderate to significant spalling/cracking at the left and right ends of the spillway inlet which extend a

As previously mentioned, the concrete associated with the intake and fixed weir area of the spillway shows minor to moderate cracking and spalling. Beyond the inlet area the remaining portion of the spillway training walls are in good condition with no concrete deficiencies noted. There appears, however, to be some minor deterioration and cracking/concrete loss along the bottom contact with the floor.

Photo 3: Upstream concrete wall at spillway. Note cracking/spalling at spillway inlet area.

2. Repair deteriorated, cracked, chipped, and spalled concrete areas on along the upstream side of the dam, within the intake area entrance, along the bottom contact with the floor of the spillway training walls, and those associated with the downstream end of the spillway training wall outlet roof section. All areas to be repaired must be clean, sound and free of contaminants. General procedures for the various repair types should be as follows:

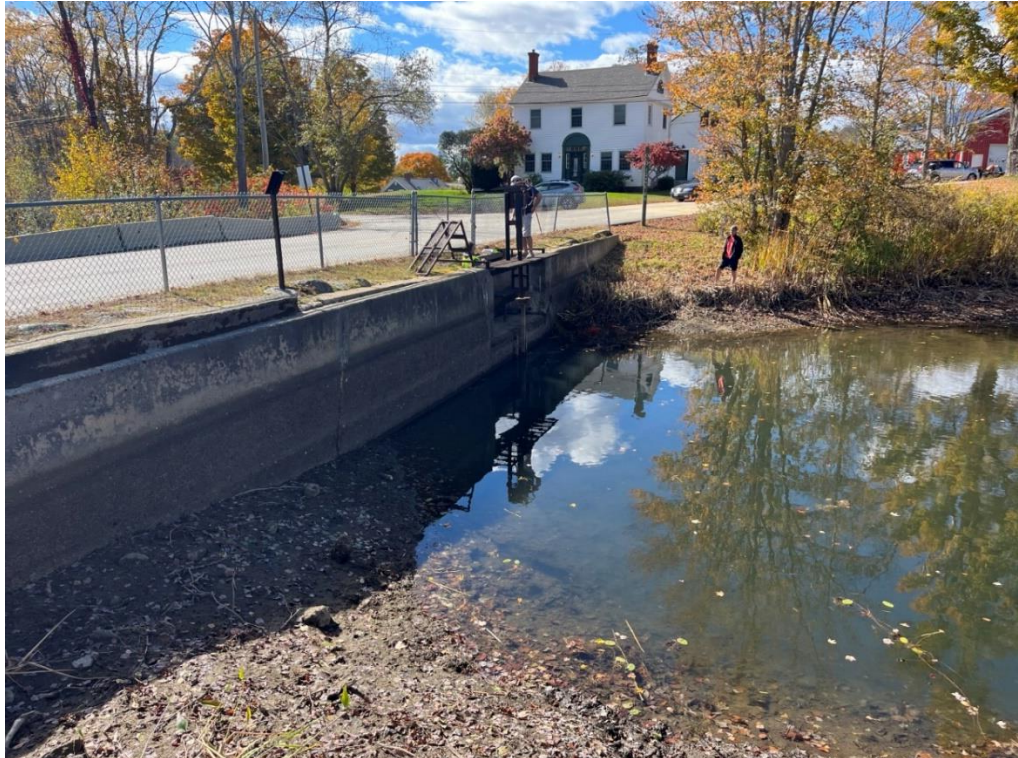
Photo 4: Upstream of the dam from left abutment.

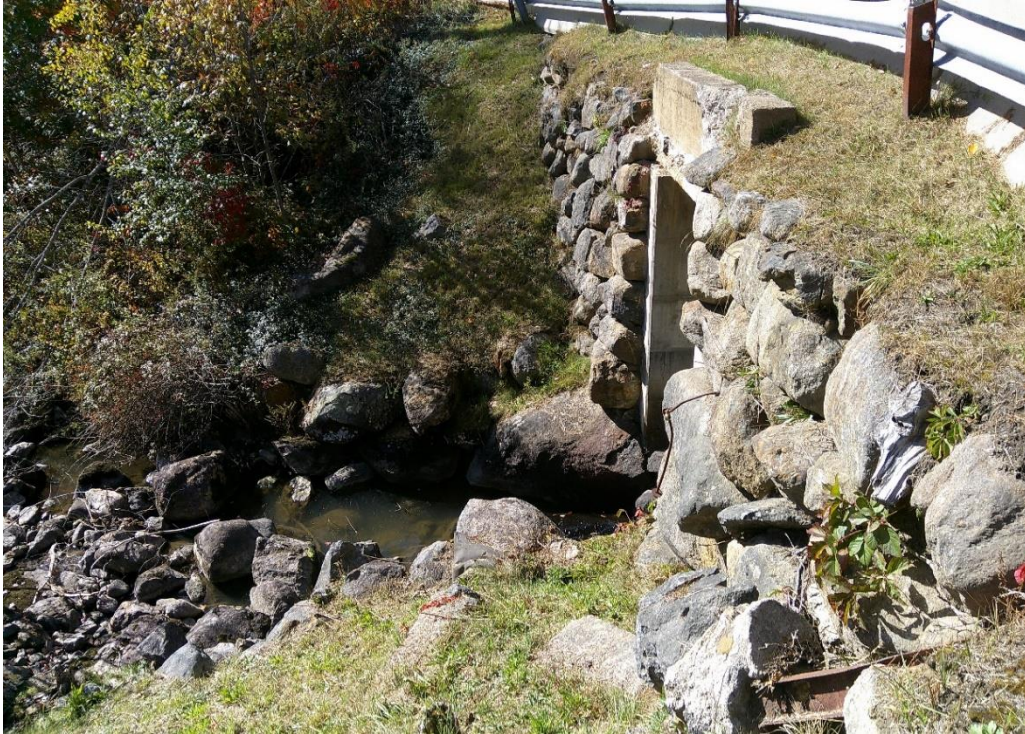
Photo 5: Downstream side of the dam from left embankment.

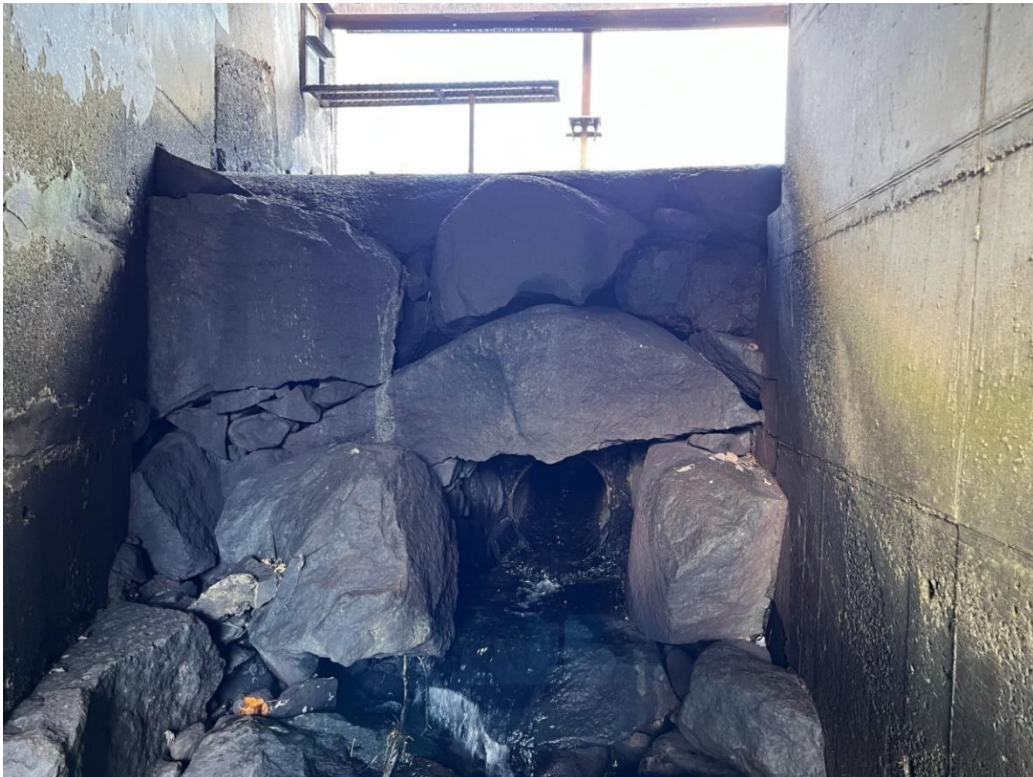
The low-level outlet consists of an 18-inch-diameter CMP with upstream end located below the weir. The downstream end is at the transition of the vertical drop with the remainder of the outlet channel some 9.5 feet downstream from the dam face. A cast-iron slide gate with manual hand wheel controls flow into the outlet pipe. At the time of the inspection the gate was initially closed. Leakage of approximately 5 to 10 gallons per minute was observed. The gate was exercised during the visit and appear to be in good working order.

Photo 6: Downstream end of 18" diameter low-level discharge pipe at the downstream side of concrete faced portion of the spillway.

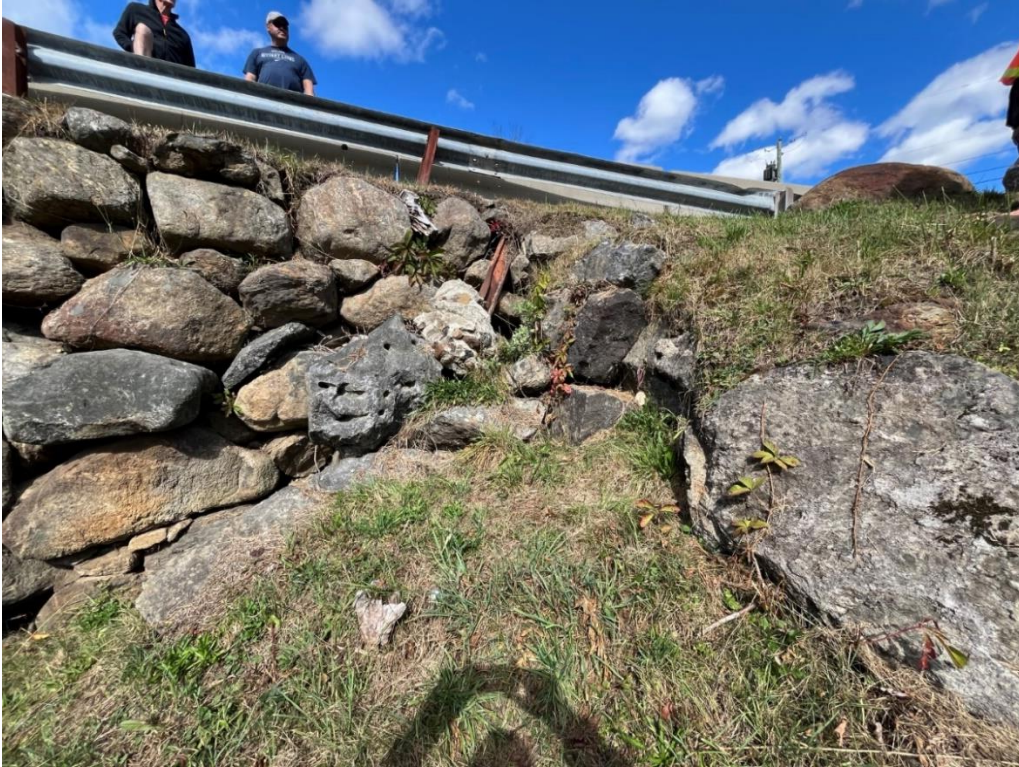
Photo 7: Downstream side of dam at the left abutment contact.

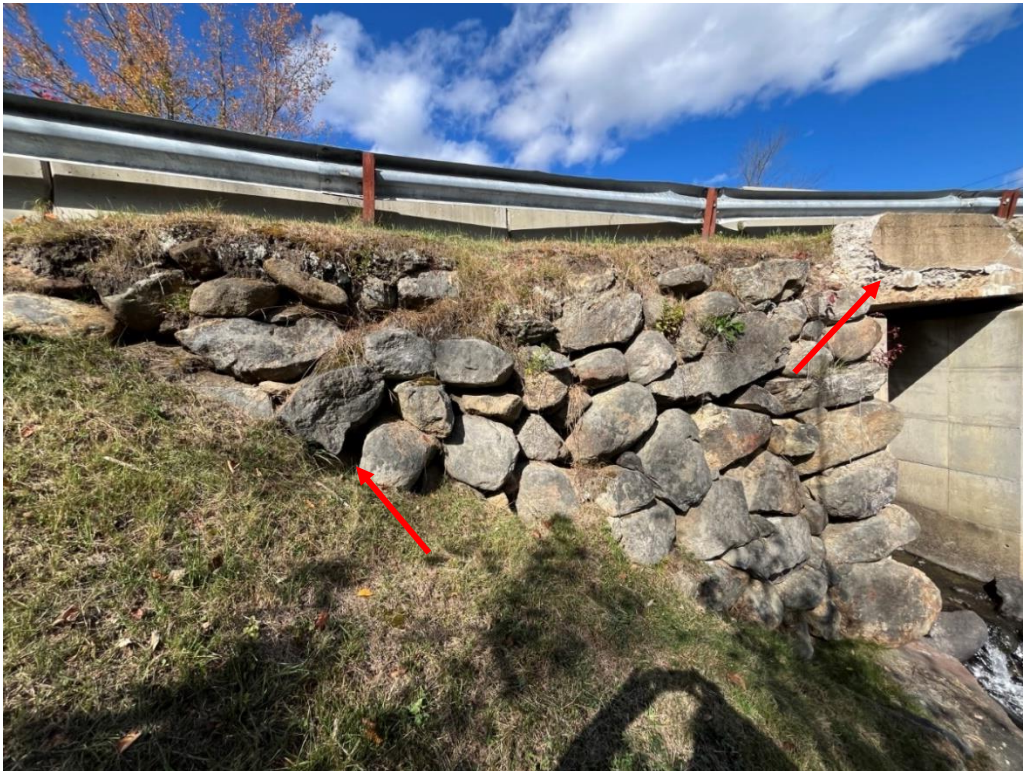
The downstream side of the dam consists of a dry-laid rounded stone wall that transitions into the sloped earth abutments. Alignment of the wall is generally adequate though there are localized areas of shifted/bulging stones, missing or large gaps in between stones. Debris (i.e., concrete/steel former guardrail piers, and miscellaneous metal steel rod debris (typical of old dams of this hybrid-style construction) present within the stone wall matrix locally on the left side of the spillway outlet. The exposed downstream end of concrete roof over the spillway outlet makes up a portion of the downstream side. It is in fair to poor condition with several sections exhibiting significant spalling and moderate concrete loss.

Photo 8: Downstream side of dam near right abutment contact.
Note – voids in dry-stone masonry and spalling of concrete roof section.

3. Fill large gaps between stones in the downstream masonry wall particularly in the area along the top portion right of the spillway outlet. Remove soil as necessary to prepare space to receive new stone. Consider removing the debris which is present in portions of the wall to the left of the spillway outlet and replace voids resulting therefrom with new stone. “Use smaller stones to “chink” smaller gaps in other areas (both left and right of the outlet) necessary so that the wall matrix is more uniform and consistent. Excess soil and debris should be disposed of off-site.
4. Clear trees vegetation within 15 feet of downstream slope and abutments, remove rootballs and backfill with compacted gravel topped with loam and seed.

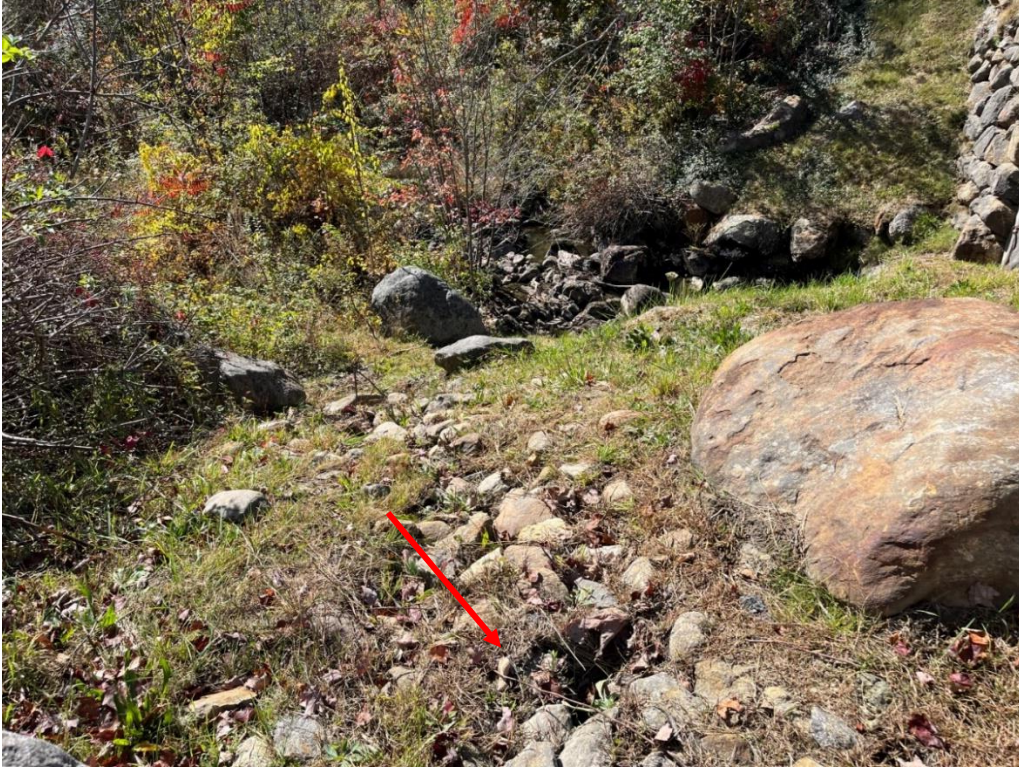
The earthen segments that make up the downstream slope extending out from the abutment contacts are generally satisfactory with adequate grass cover. There were no wet areas or seepage observed (though it is noted the impoundment level was approximately 4 feet below normal pool at the time of the inspection). There is some minor sloughing on left side. Erosion from surface water road runoff was observed in the left embankment. A stone channel exits as erosion protection on this side, however, there are gaps in the channel and runoff appears to occur outside the channel leading to further erosion of the slope.

Photo 9: Erosion from road runoff in the stone-lined channel in the left downstream embankment portion facing downstream.

1. Repair the erosion caused by surface water runoff. This includes the area on the right upstream abutment, the depressed/eroded area beneath/downstream of the “jersey” barrier on the downstream side of the crest roadway, and adjacent to the stone-lined channel in the left downstream embankment portion. Thereafter implement measures to prevent future surface water runoff erosion.

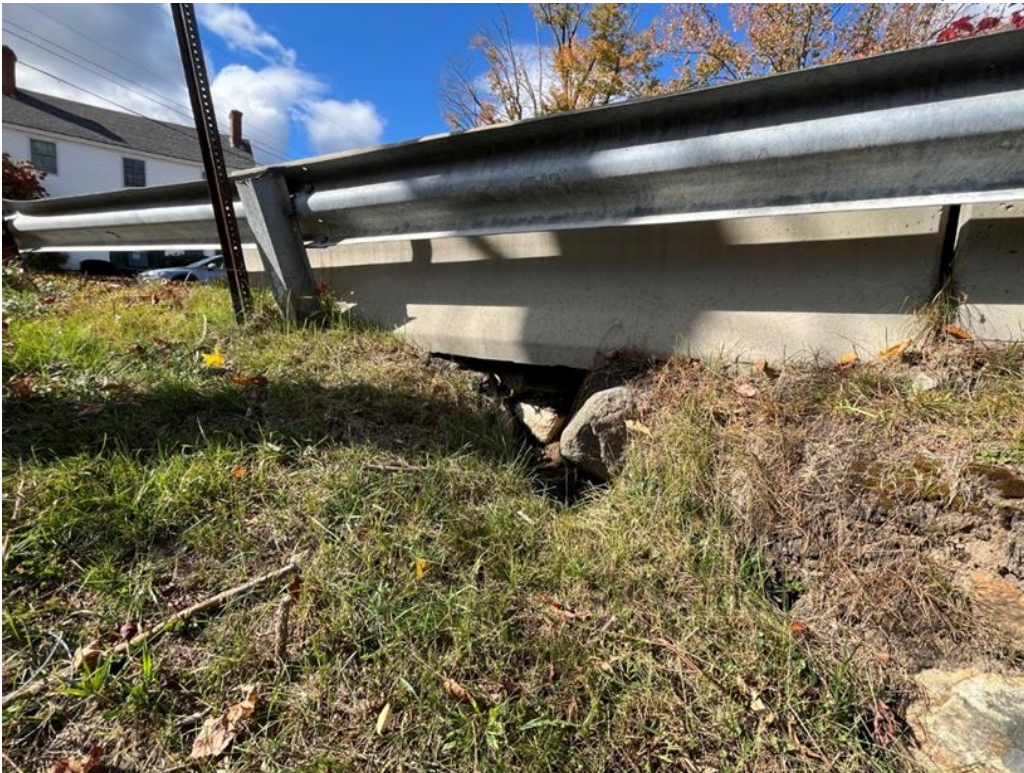
Photo 10: View of depressed/eroded area beneath/downstream of the “jersey” barrier on the downstream side of the crest roadway. Deficiency caused by uncontrolled surface water runoff.

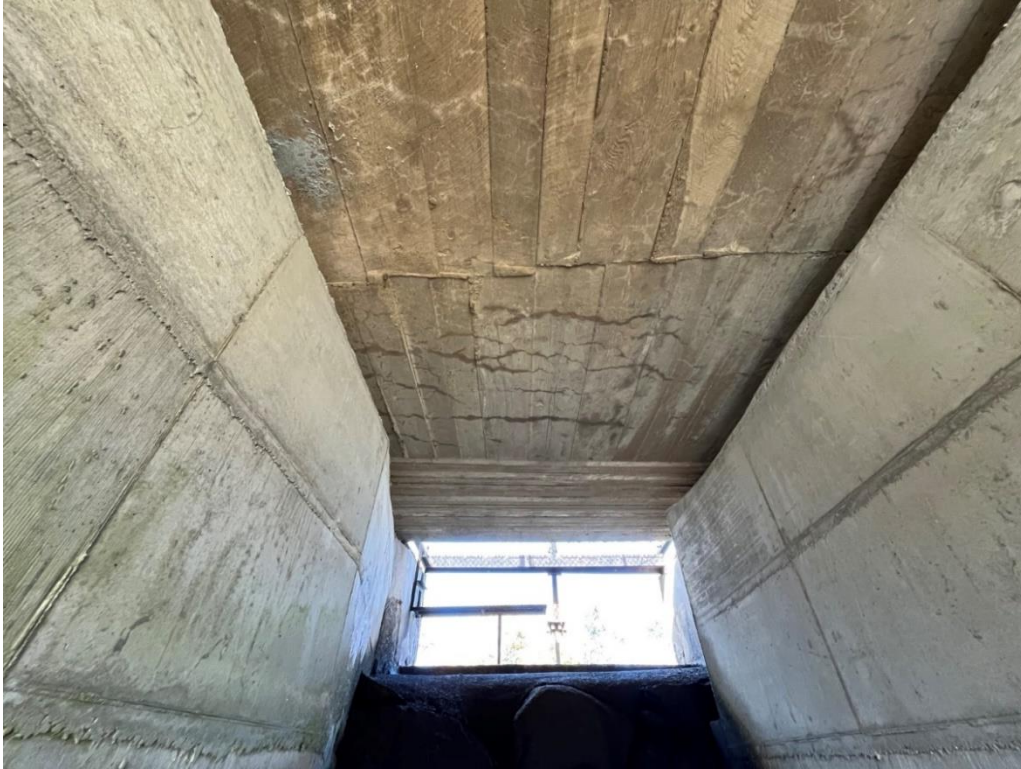
Photo 11: Top view of concrete side channels and roof deck (supporting crest roadway) downstream of low-level outlet discharge pipe.

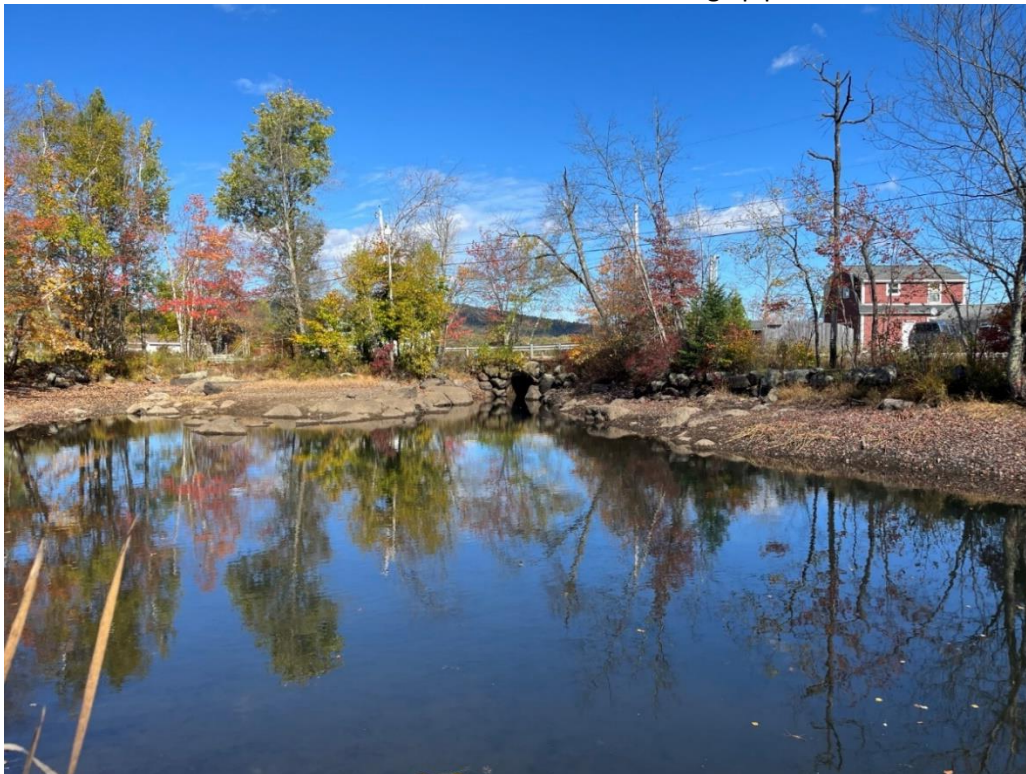
Photo 12: View of pond from top of dam
